INDOOR AIR QUALITY ASSESSMENT

**North Shore Community College
Beverly Campus
100 Cummings Center, Suite 121 E
Beverly, Massachusetts**

Prepared by:
Massachusetts Department of Public Health
Center for Environmental Health
Emergency Response/Indoor Air Quality Program
August 2005

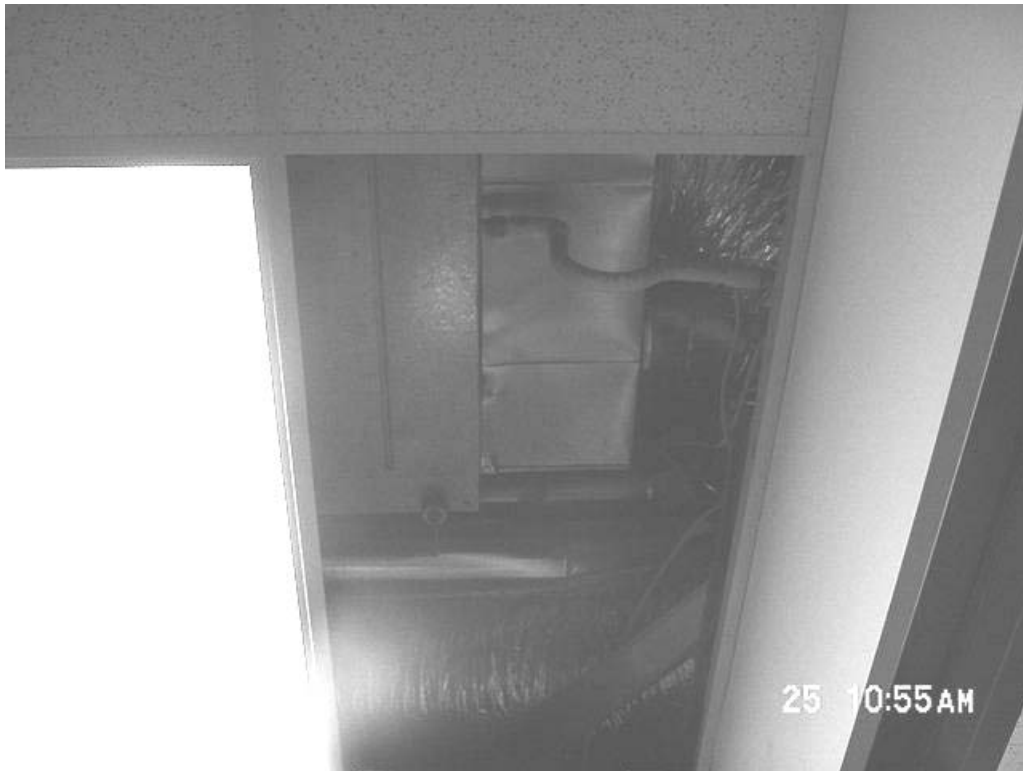
Picture 1

Ventilation is provided by a heating, ventilating and air conditioning (HVAC) system that consists of heat pumps located above ceiling tiles (Picture 1). Outside air is drawn in through air intakes located on the exterior wall of the building (Picture 2); air is conditioned and distributed through ducted ceiling vents (Pictures 3 through 5). Air is filtered and returned to the heat pumps by ducted ceiling-mounted return vents (Picture 6). This system was operating throughout the NSCC occupied area during the assessment. Thermostats that control the HVAC

Heat Pump above Ceiling Tile System

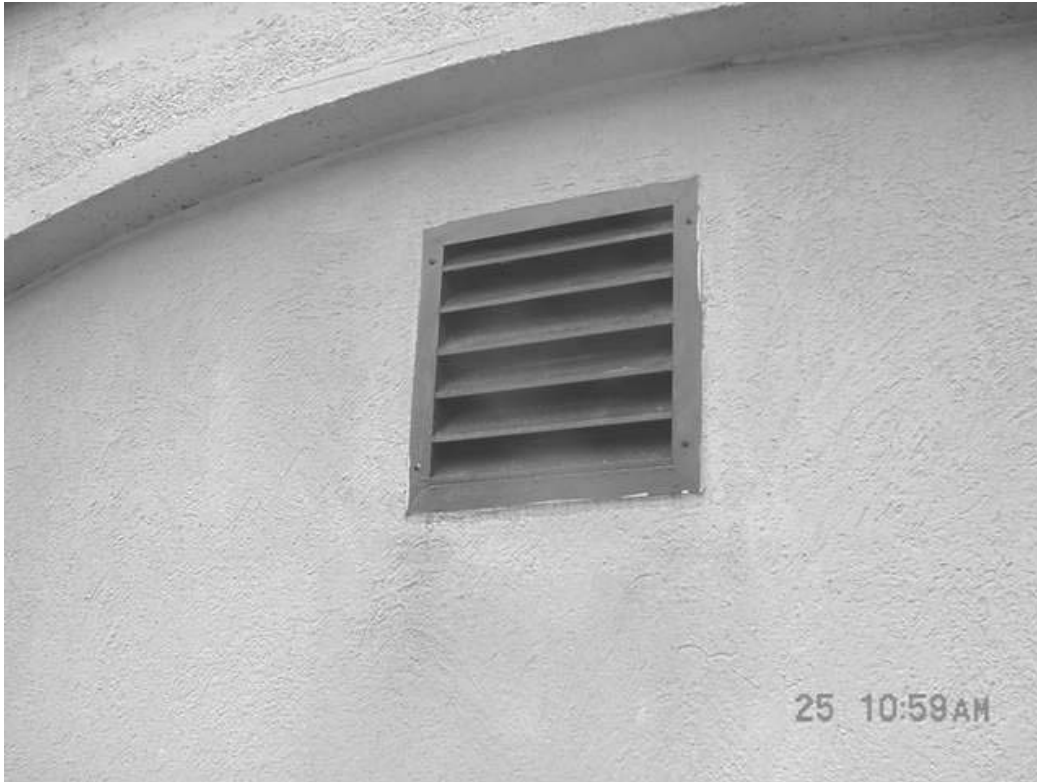
Picture 2

Outside Air Intake

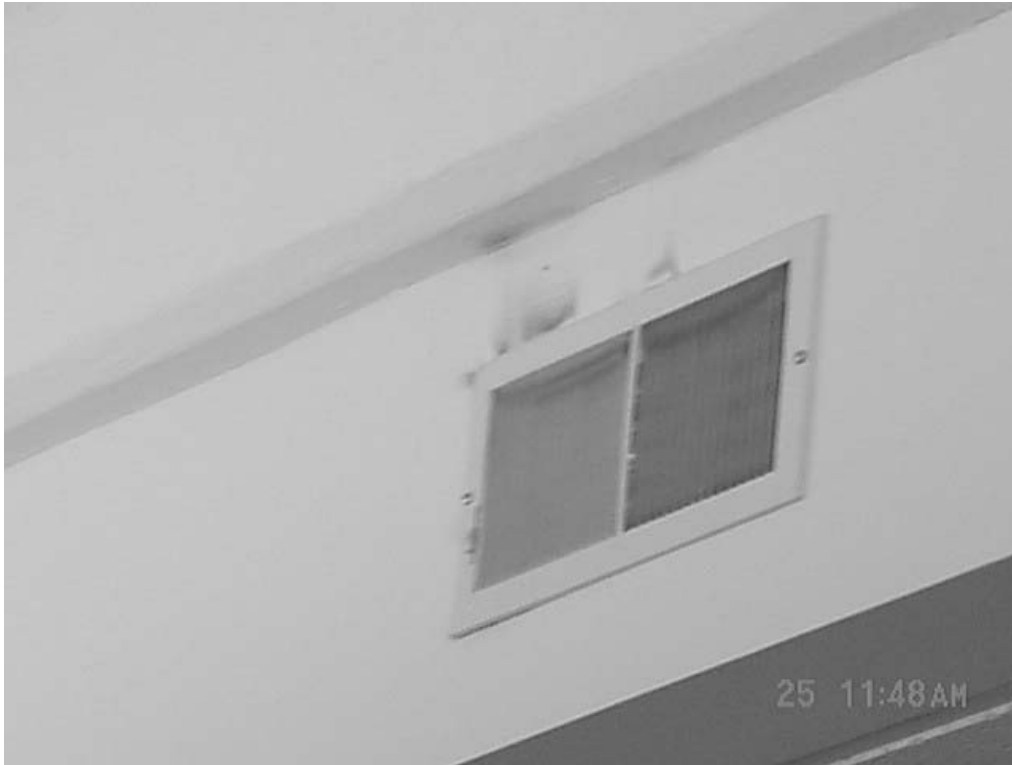
Picture 5

Ceiling-Mounted Air Diffuser, Note Stains on Wall near Vent

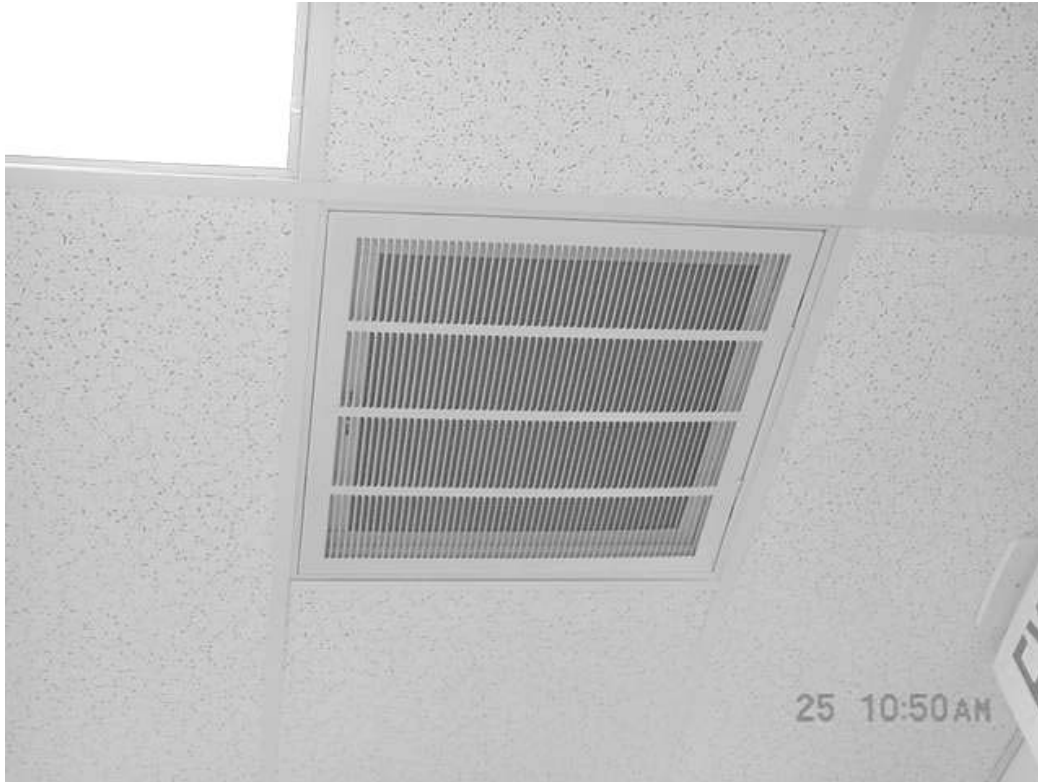
Picture 6

Air handling units (AHUs) are normally equipped with filters that strain particulates from airflow. Filters for this system are installed within the return vent frame. The type of filter installed at this NSCC location provide minimum of filtration. Mr. Parziale reported that building management is planning to switch to high-efficiency pleated filters. MDPH staff could not determine whether fresh air intakes were equipped with air filters because of design constraints. If fresh, unfiltered air from the outside is drawn into the AHUs, particulates would likely be distributed into the NSCC space. In order to decrease aerosolized particulates, disposable filters with an increased dust spot efficiency can be installed. The dust spot efficiency is the ability of a filter to remove particulates of a certain diameter from air passing through the filter. Filters that have been determined by ASHRAE to meet its standard for a dust spot efficiency of a minimum of 40 percent would be sufficient to reduce airborne particulates

Return Vents Containing Filters

5. Continue with plans to increase the dust-spot efficiency of HVAC filters. Prior to any increase of filtration, each piece of air handling equipment should be evaluated by a ventilation engineer as to whether it can maintain function with more efficient filters.

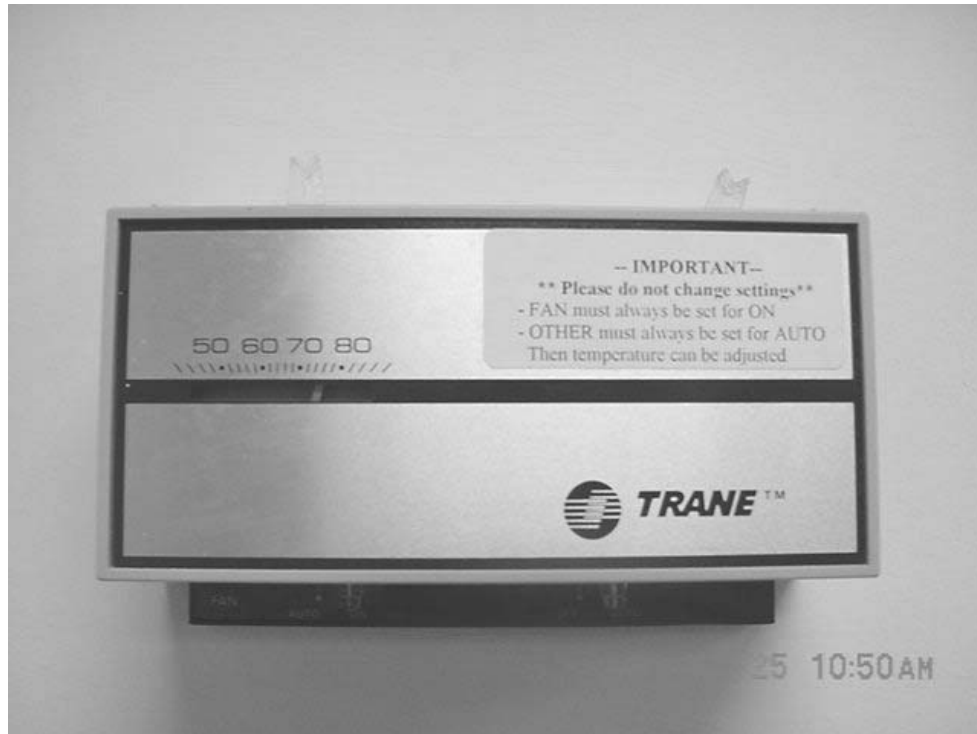
Picture 7

system have fan settings of “on” and “automatic”. Thermostats were set to the fan “on” setting which is recommended by the MDPH to provide continuous air circulation (Picture 7).

Thermostat for HVAC System

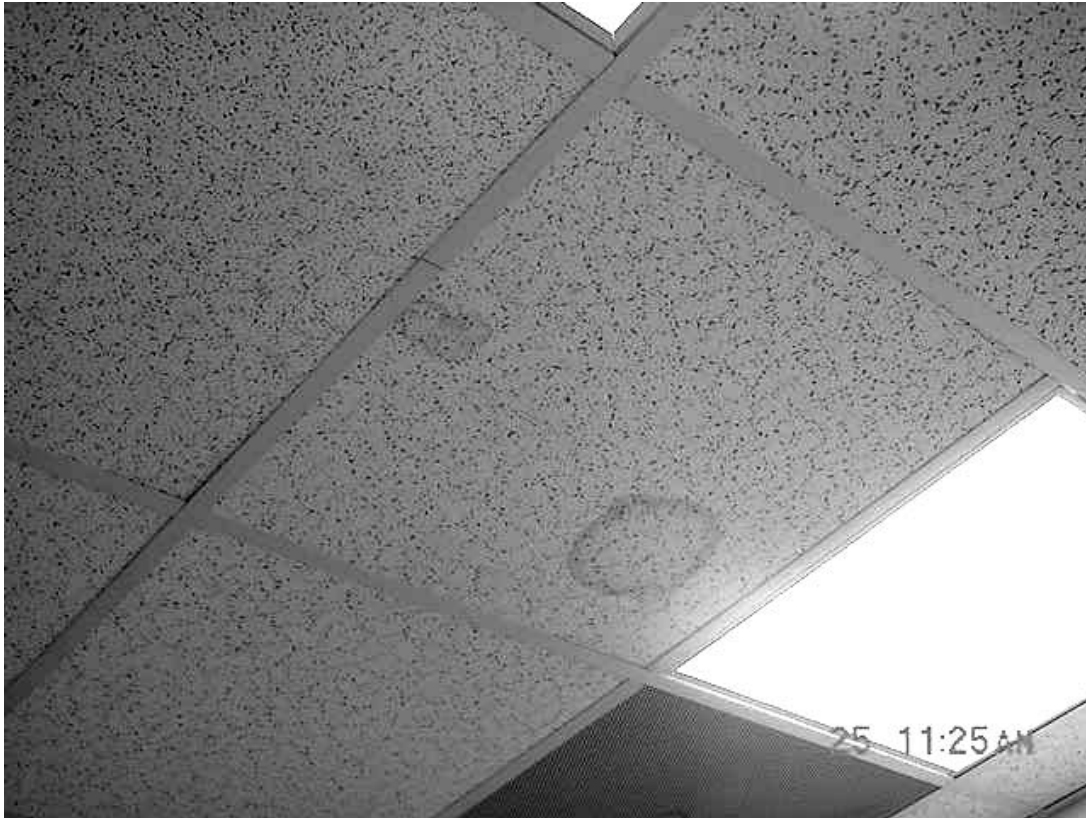
Picture 8

Several areas had water-damaged ceiling tiles, which can indicate dripping from condensation or leaking from the plumbing system (Picture 8). Water-damaged ceiling tiles can provide a source of mold and should be replaced after a water leak is discovered and repaired. The US Environmental Protection Agency (US EPA) and the American Conference of Governmental Industrial Hygienists (ACGIH) recommends that porous materials (carpeting, ceiling tiles, etc.) be dried with fans and heating within 24 to 48 hours of becoming wet (US EPA, 2001; ACGIH, 1989). If porous materials are not dried within this time frame, mold growth may occur. Water-damaged porous materials cannot be adequately cleaned to remove mold growth. The application of a mildewcide to moldy porous materials is not recommended.

Water Damaged Ceiling Tiles

10. Ensure all roof leaks are repaired, and replace water damaged ceiling tiles. Examine the area above and around water-damaged areas for mold growth. Disinfect areas with an appropriate antimicrobial as needed.

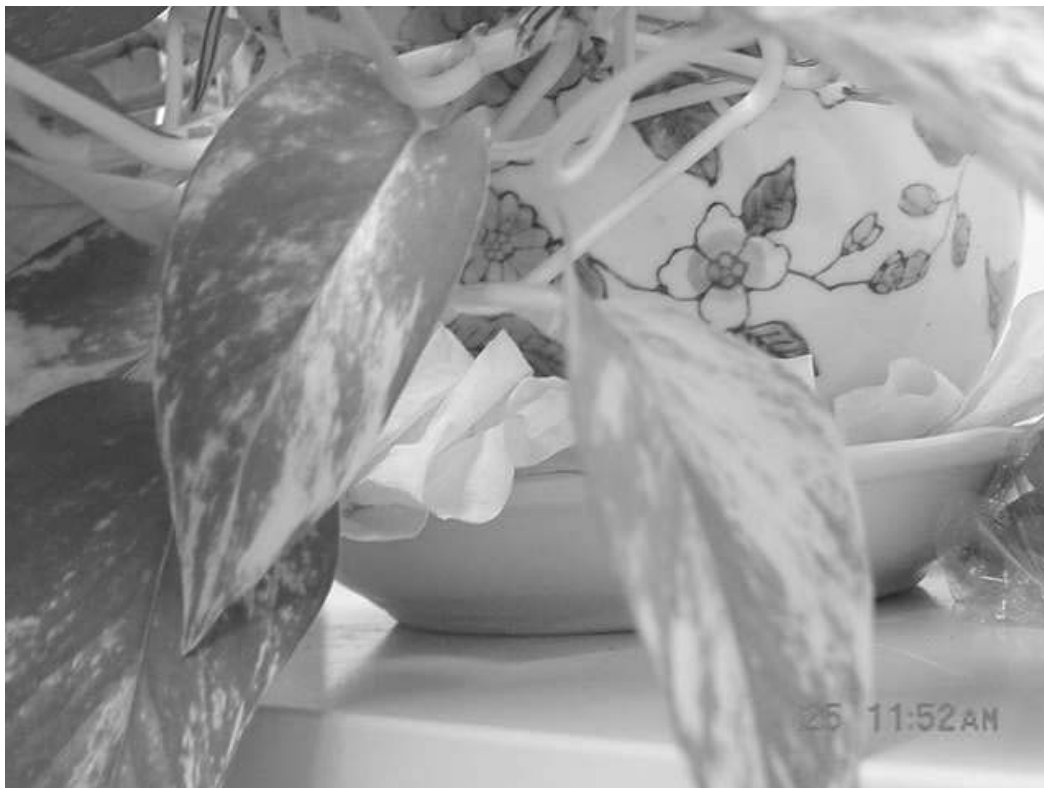
Picture 9

Several areas contained plants. Plants, soil and drip pans can serve as sources of mold growth, and thus should be properly maintained. Plants should have drip pans to prevent wetting and subsequent mold colonization of window frames. One plant was observed on paper towels (Picture 9), which can absorb moisture and provide a medium for mold growth. Plants should also be located away from ventilation sources to prevent aerosolization of dirt, pollen or mold.

Plant on Paper Towels

11. Ensure plants have drip pans. Examine drip pans periodically for mold growth and disinfect with an appropriate antimicrobial where necessary. Remove paper towels from beneath plants.

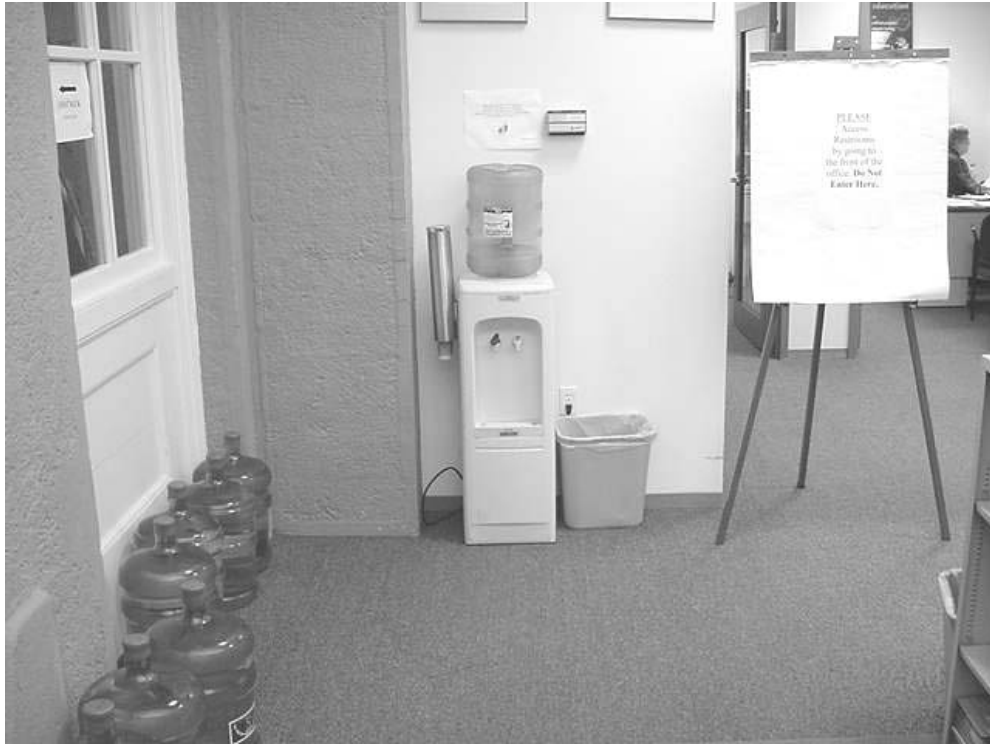
Picture 10

Water coolers were observed on carpeting in a number of areas (Picture 10). Water spillage or overflow of cooler catch basins can result in the wetting of the carpet. In addition, some of the coolers had residue/build-up in the reservoir. These reservoirs are designed to catch excess water during operation and should be emptied/cleaned regularly to prevent microbial and/or bacterial growth.

Water Cooler on Carpeting

12. Relocate or place tile or rubber matting underneath water coolers in carpeted areas.
Clean and disinfect reservoirs as needed to prevent microbial growth.
13. Consider posting signs in parking areas adjacent to the building instructing vehicle operators to shut off engines as soon as possible but in no case more than five minutes as required by Massachusetts General Laws 90:16A.
14. Refer to the resource manual and other related indoor air quality documents for further building-wide evaluations and advice on maintaining public buildings. These resources are located on the MDPH's website: http://mass.gov/dph/indoor_air.

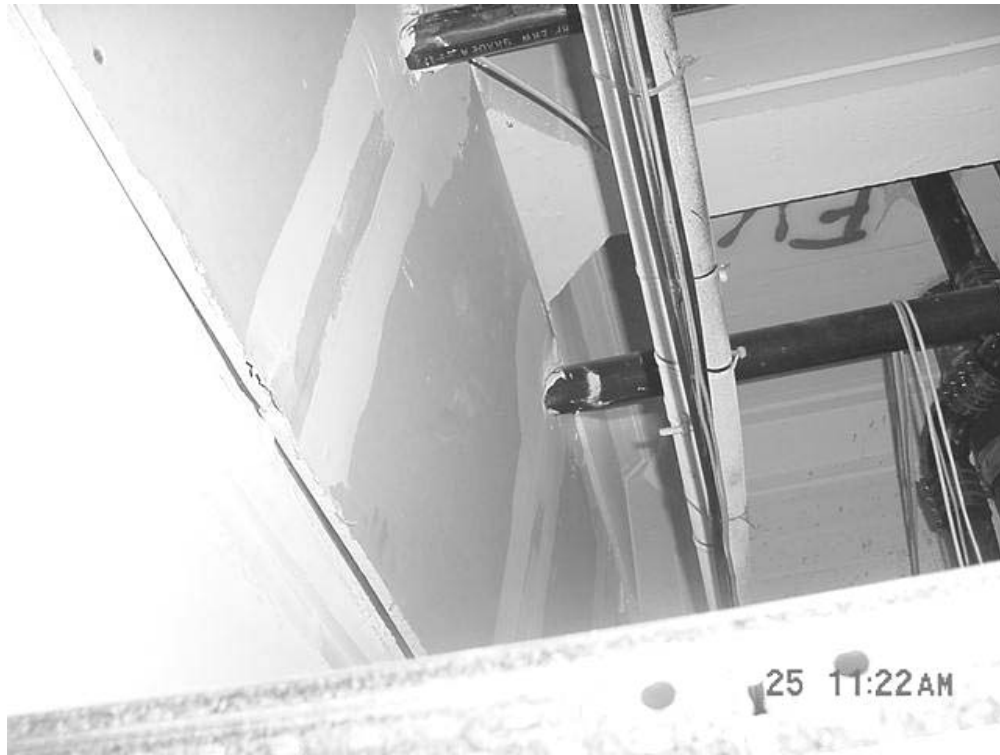
Picture 11

Although no VOCs were detected the day of the assessment, potential pathways were identified. The common wall between the NSCC and adjacent beauty salon is penetrated by utility holes for pipes, electricity, etc. (Picture 11). The utility holes around pipes examined appeared to be tight; however, the terminus of the pipes in the beauty salon could not be

Pipes through Common Wall in Adult Learning Center, Note Little Space around Pipes

8. Clean supply/return vents periodically of accumulated dust.
9. Ensure all utility holes and other potential pathways are properly sealed in both the NSCC and their terminus to reduce/eliminate pollutant paths of migration from the beauty shop.

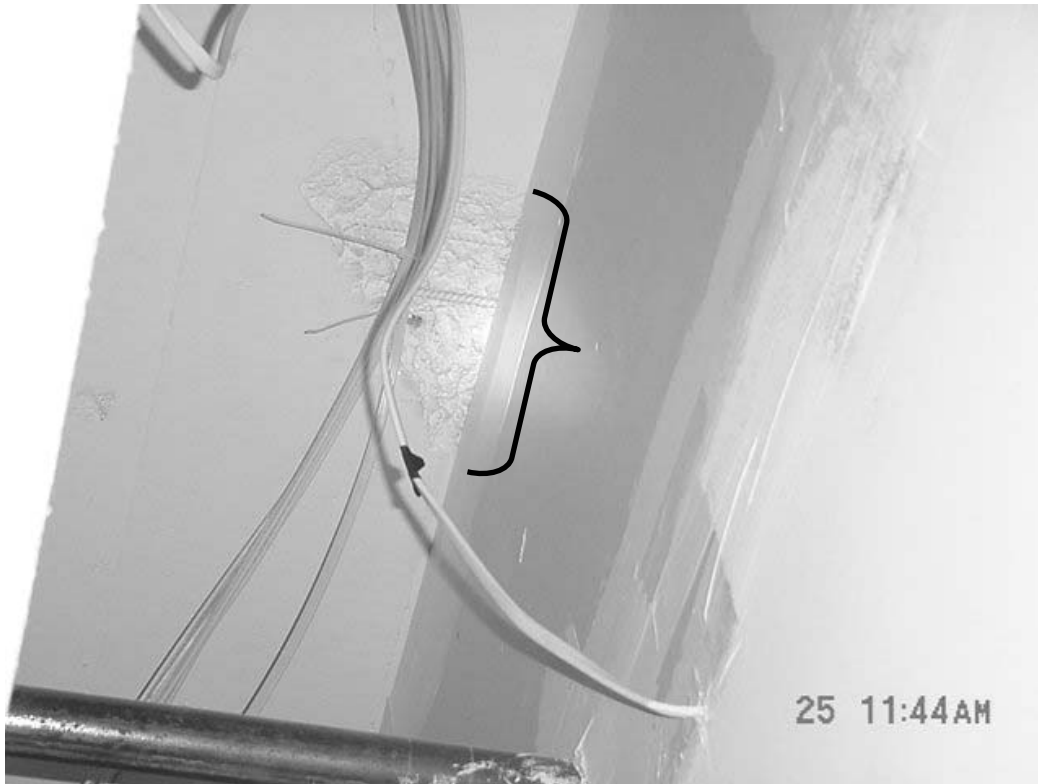
Picture 12

examined. The ceiling plenum in room CL 01 was examined, and a space along the common wall that could serve as a potential pathway for fumes/odors between the beauty salon and NSCC was also observed (Picture 12).

Damaged Ceiling at Junction of Wall Separating NSCC and the Beauty Salon

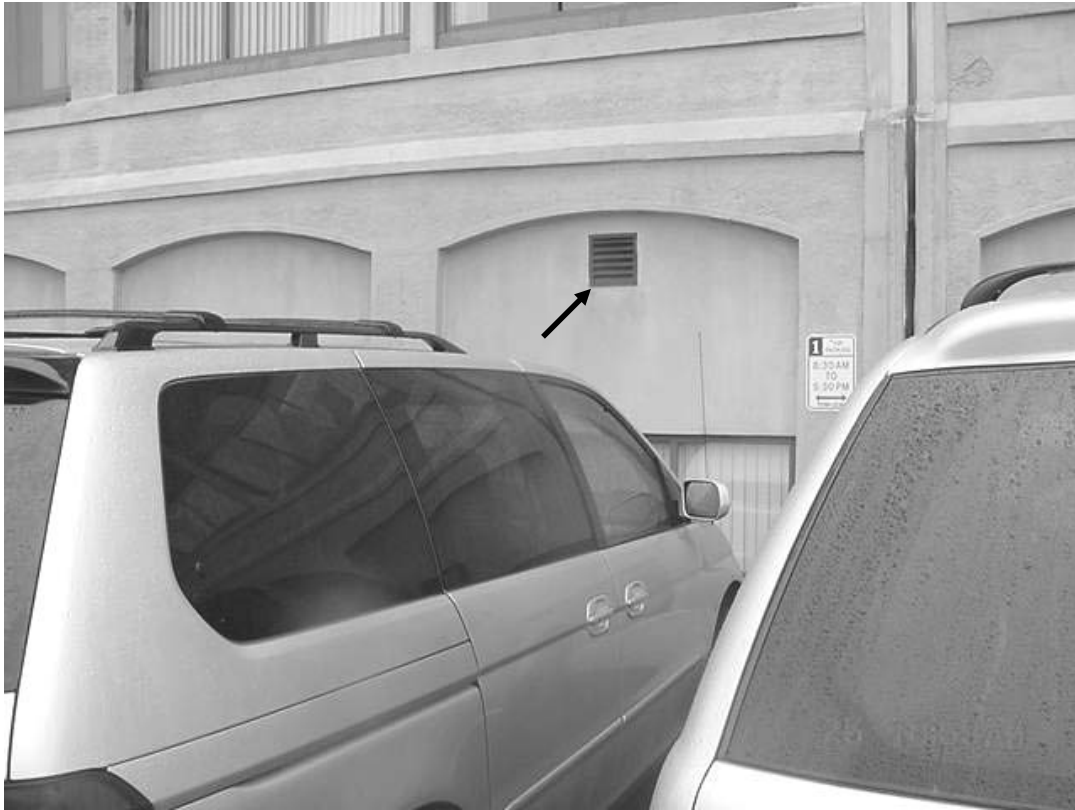
Finally, although no complaints of vehicle exhaust odors were reported in the building, the potential for vehicle exhaust odor entrainment exists. Picture 13 shows the close proximity of the fresh air intakes to the parking lot. Under certain wind/weather conditions, vehicle exhaust can be drawn into or entrained in the air intakes. Entrainment of vehicle exhaust to the building may in turn provide opportunities for exposure to combustion products such as carbon monoxide. M.G.L. chapter 90 section 16A prohibits the unnecessary operation of the engine of a motor vehicle for a foreseeable time in excess of five minutes (MGL, 1986).

Proximity of Air Intake to Parked Vehicles
